Property Condition Assessment

[REDACTED], Kailua Kona, HI 96740-2619

23A25-31105-PCA

March 24, 2023

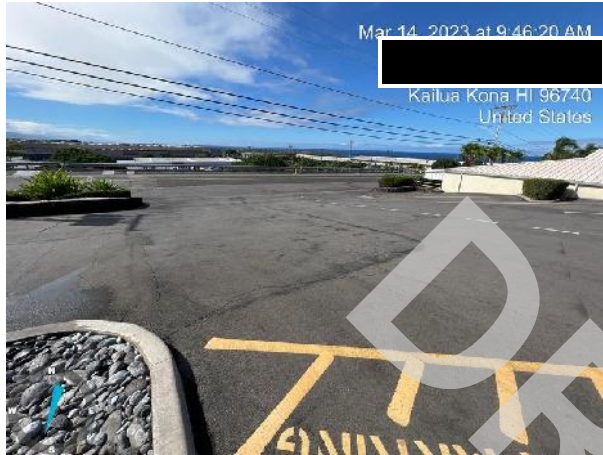
ITEM	DESCRIPTION	CONDITION
	<p>Number of reserved ADA spaces: 2</p> <p>Number of other reserved spaces: 0</p> <p>TOTAL parking spaces: 36</p>	
Age/Last action	Driving aisles and parking areas are original. Driving aisles and parking areas are repaired and/or replaced on an ongoing, as-needed basis.	
CONCERNS		
Issues observed	No significant concerns affecting the Property's Pavement or Curbing were noted or reported.	
RECOMMENDATIONS		
Findings	Asphalt parking areas typically have a EUL of 20 to 25 years depending on the level of maintenance, traffic, and weather conditions. The EUL can be extended significantly with periodic sealing of these surfaces. CREtelligent has included costs for periodic sealing and striping of the parking areas in the Modified Capital Reserve Table. In addition, allowances for overlaying of 15% to 20% of the most heavily worn or trafficked areas during the evaluation period are accounted for in the Modified Capital Reserve Table.

Asphalt and curbing looking towards driveway

COST RECOMMENDATION	EUL	EFF AGE	RUL	YEAR	COST
Seal-Coat Asphalt Surfaces	7	5	2	29	\$19,500 \$19,500
Re-Stripe Parking Lot	7	5	2	29	\$250 \$250
Total					\$39,500

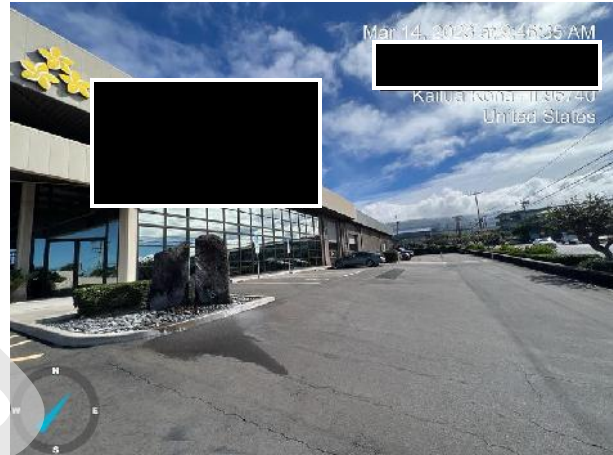
Asphalt and parking

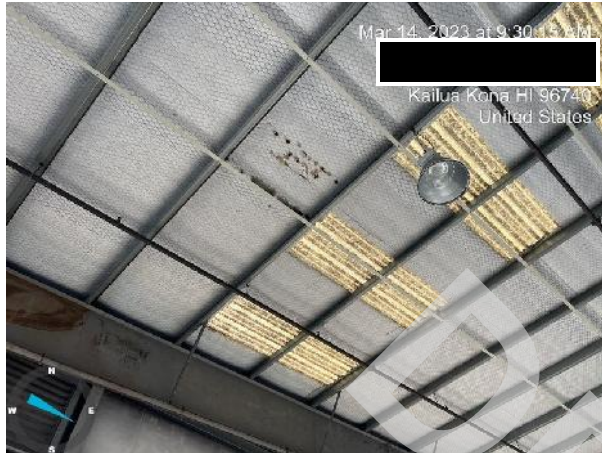
- Damaged insulation beneath the roof was observed in one area of the building. Staining on the floor was observed beneath this damage, suggesting possible roof leakage. We have included costs in the Immediate Needs Table for inspection and repair of this area by a roofer.
- Depending on the area that is to be leased for product storage and the type of product to be stored smoke/heat detectors might be appropriate. Costs are included in the Immediate Needs Table for consultation by a fire safety consultant.

COMPONENTS OBSERVED		
Roof type	The roofing system has a slight slope, and is covered with screw-down ribbed metal panels with integrated fiberglass panels.	Good
Roof drainage	Gutters are located behind parapets which lead to downspouts discharging to paved areas near the building or to drywells.	Good
Parapets and coping	The parapet walls are extensions of the perimeter walls and steel framed and sided with anodized aluminum coping. Counter flashing at the parapets walls is constructed of galvanized metal or aluminum.	
Other	Typical roof penetrations such as roof vents, electrical conduit, utility pipes, etc. are present. These penetrations are flashed with aluminum and caulked and sealed.	
Age/Last action		
CONCERNS		
Leaks	Damaged insulation was noted on the underside of the roof in the northeast corner of the building. Floor staining beneath was also observed. No obvious damage was noted on the roof in this area.	Good

Damaged insulation

COST RECOMMENDATION	EUL	EFF AGE	RUL	YEAR	COST
Roof assessment and repair	20	20	0	Immediate	\$2,500
Total					\$2,500

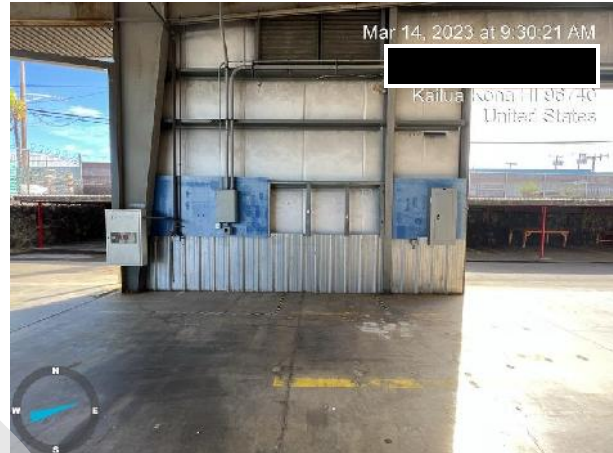
Floor staining beneath insulation damage

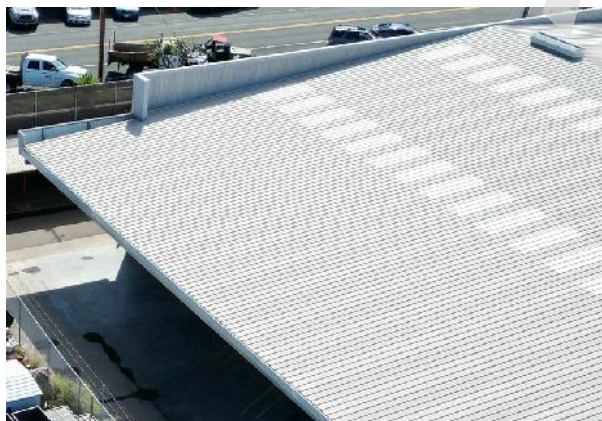
Area of roof with damaged insulation

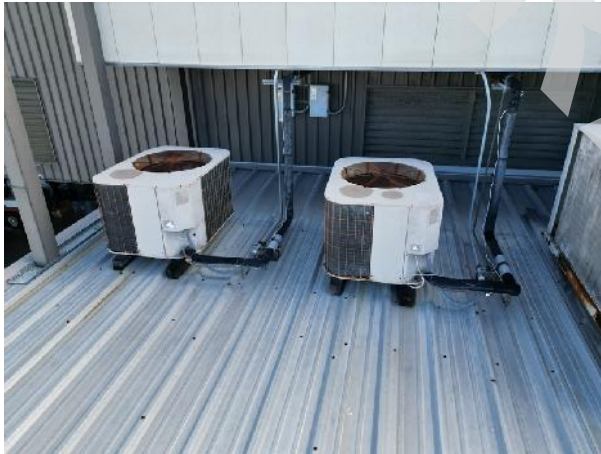
Other	No other concerns relating to the HVAC system were noted or reported.	Good
RECOMMENDATIONS		
Findings	<p>The majority of the heating and cooling components are presumed to be 20 years old. The average EUL of condensers of this size and type is 15-20 years and air handlers with electric heat have an EUL of 25 years. Due to SEER 13 regulations enacted in January 2006, air handlers and furnaces produced to work with SEER 10-rated remote condensers may not work with newer SEER 13-rated remote condensers. Consequently, when the remote condenser requires replacement, the furnace may also require replacement so the cooling coil will be properly rated. Based on their average effective useful life, current condition, and reported maintenance program, partial replacement of the HVAC units is recommended during the analysis term. Allowances are included in the Modified Capital Reserve Table. (Note: the above is not applicable to fan coil units.)</p>

Rooftop units

COST RECOMMENDATION	EUL	EFF AGE	RUL	YEAR	COST
Replace Rooftop Package Units	20	18	2	2	\$9,375
				3	\$9,375
				4	\$9,375
				5	\$9,375
Total					\$37,500

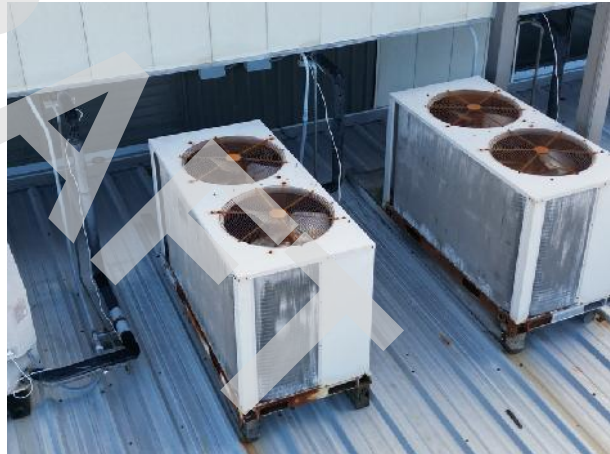
Rooftop units

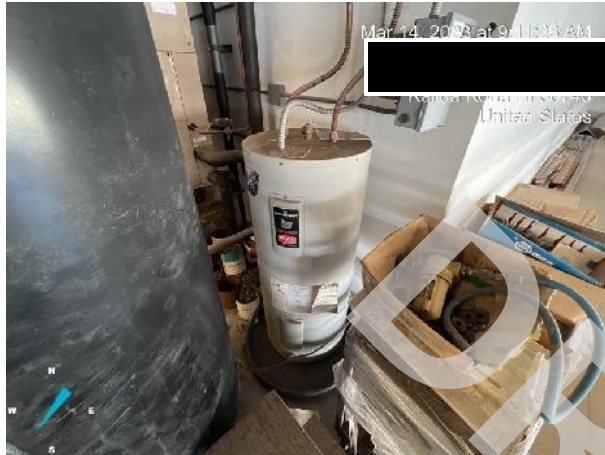
Hot water production	A single electric water heater was observed on the mezzanine level. This 50 gallon unit was manufactured in 2003.	
Other	Sanitary wastewater is discharged to a septic tank located on the south side of the building. Reportedly the tank is pumped annually, and has no discharge. Floor drains in a vacant area of the building reportedly discharge to a dry well in the northeast corner of the property. In the area used to wash vehicles an interceptor is present. Reportedly this interceptor is for sediment mainly and liquid discharge is to a second dry well.	
Age/Last action	The supply, sanitary, and vent lines are original, and their repair or replacement is addressed on an as-needed basis.	
CONCERNS		
Inoperable equipment	The plumbing systems and equipment were operational at the time of the inspection. No evidence of significantly obsolete equipment was noted or reported.	Good

Water heater

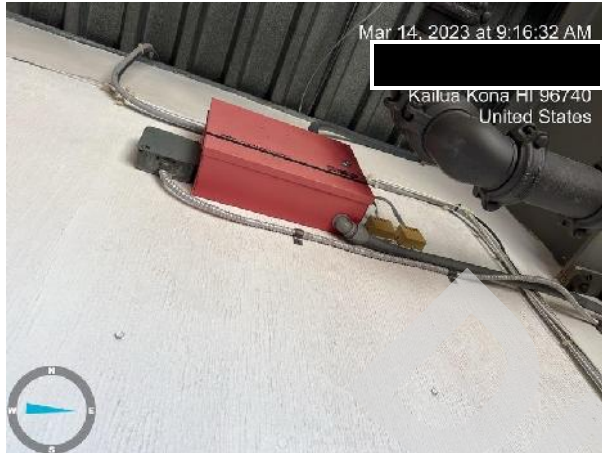
CONCERNS		
Expired inspection certificates	All observed fire-protection and life-safety inspection certificates were dated April 2022 and are therefore current.	Good
Inoperable equipment	The life safety systems were operable at the time of the inspection. No evidence of significantly obsolete equipment was noted or reported.	Good
Other	NA	
RECOMMENDATIONS		
Findings	Depending on the nature of the product to be stored on site by [REDACTED] and the location of the storage, installation of smoke/heat detectors might be appropriate. We have included a cost in the Immediate Needs Table for consultation with a fire protection professional to assist in this determination.

Fire alarm panel

COST RECOMMENDATION	EUL	EFF AGE	RUL	YEAR	COST
Fire safety consultation	20	20	0	Immediate	\$1,000
Total					\$1,000

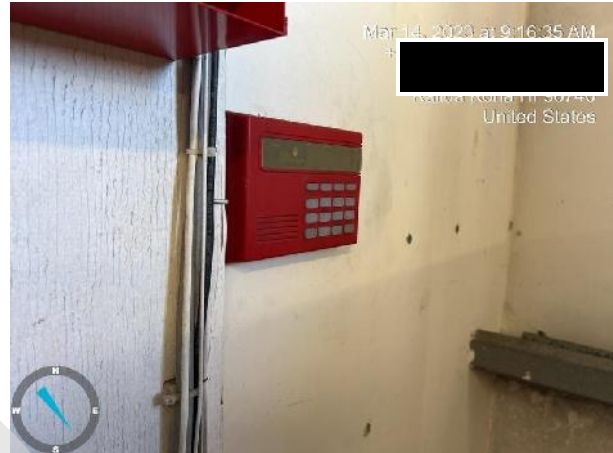
Fire alarm annunciator
