Property Condition Assessment

Subject Property:
Main Street, Anytown, CA 90000

RE Property Condition Assessment of
Sample Manufacturing
Main Street
Anytown, CA 90248
Warehouse, Storage

CREtelligent Project No.: 22K02-38231-130

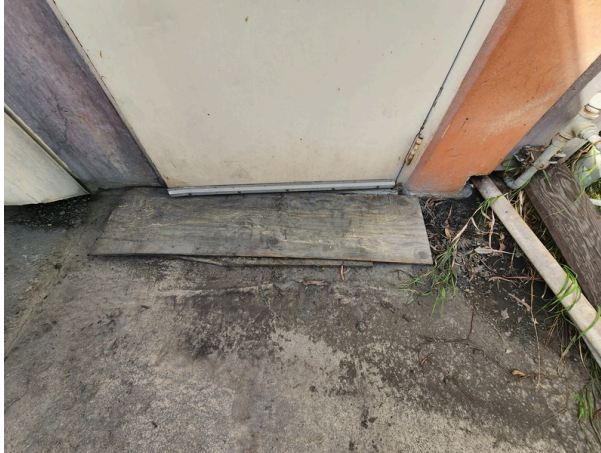
View of northeast elevation of building showing depression of paving.

COST RECOMMENDATION	EUL	EFF AGE	RUL	YEAR	COST
Redirect Storm Water Away from Building	-	-	0	Immediate	\$3,000
Total					\$3,000

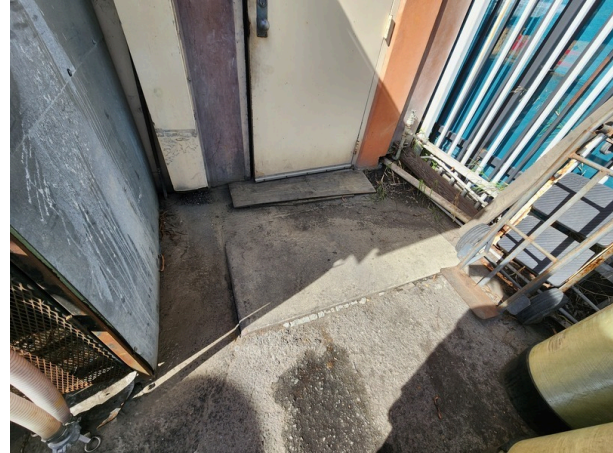
View of northeast elevation of building showing depression directing storm water toward building foundation.

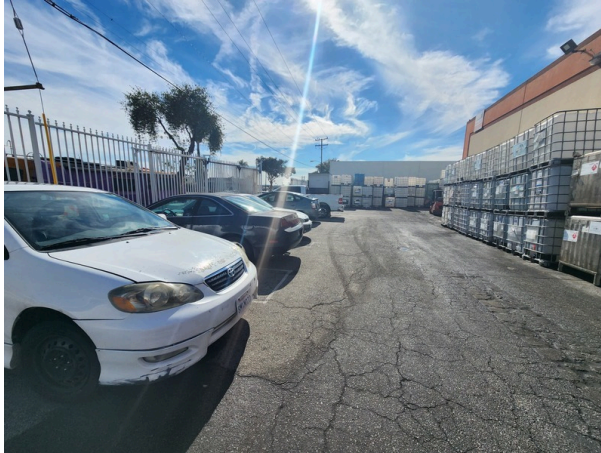
Extensive cracking of asphalt paving and faded parking stall striping.

COST RECOMMENDATION	EUL	EFF AGE	RUL	YEAR	COST
Repair, Seal Coat, and Re-Strip Paved Areas	8	7	1	1 8	\$3,000 \$3,000
Asphalt Full Depth Repair	-	-	0	1	\$12,500
Total					\$18,500

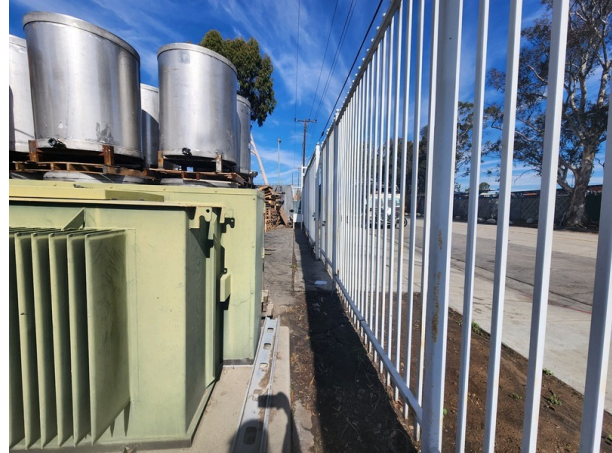
No curbing at boundary of parking area.

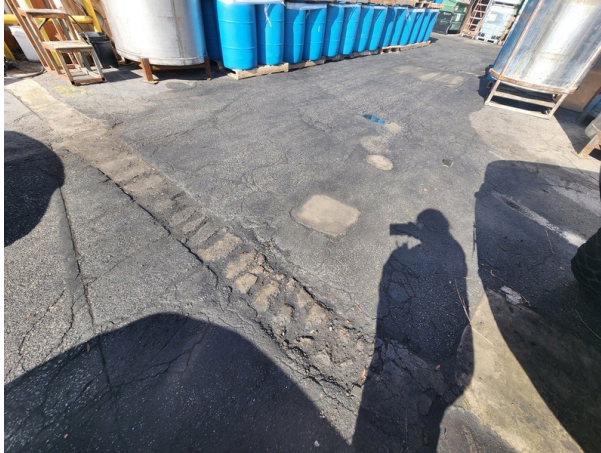
Degraded asphalt pavement.

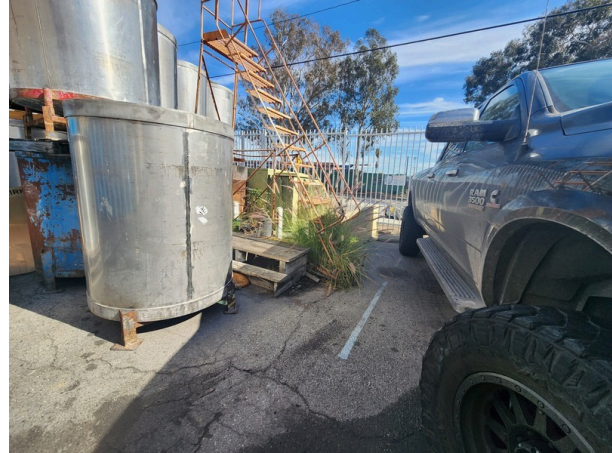
ADA parking stall with no signage.

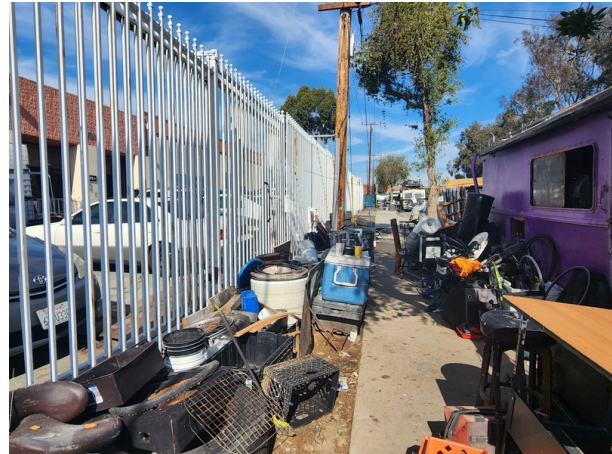
Eastern Property boundary with bare soil and accumulated trash.

COST RECOMMENDATION	EUL	EFF AGE	RUL	YEAR	COST
Remove Dumped Items, Restore Landscaping, and Effect Repairs	-	0	-	Immediate	\$2,000

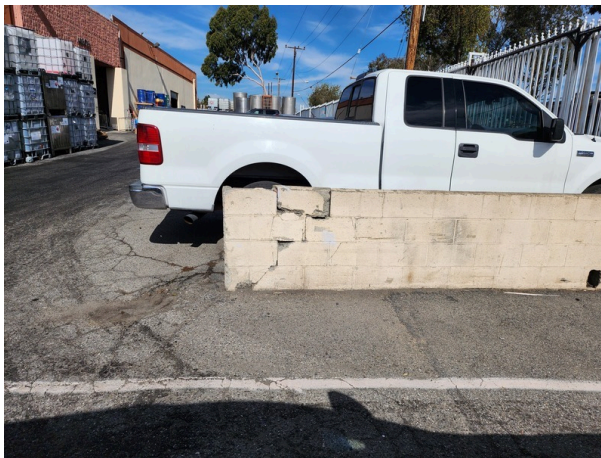
Damaged CMU wall at entrance.

COST RECOMMENDATION	EUL	EFF AGE	RUL	YEAR	COST
Repair CMU Wall	0	0	0	Immediate	\$1,500
Replace Railing at Entrance	0	0	0	Immediate	\$750
Paint Wrought Iron Fence	3	1	2	2 5 8 11	\$2,135 \$2,135 \$2,135 \$2,135
Total					\$12,790

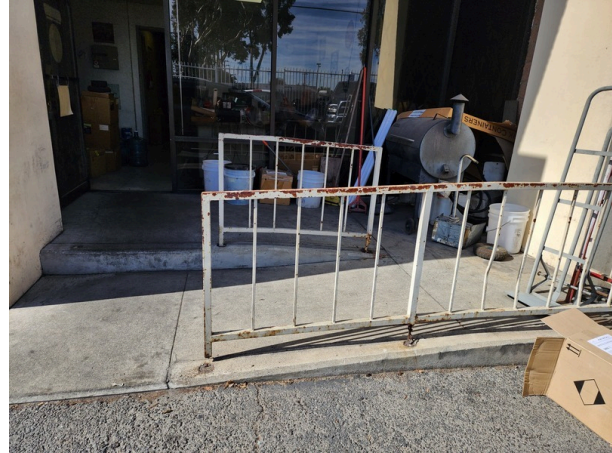
Railing at entrance which is damaged and rusted.

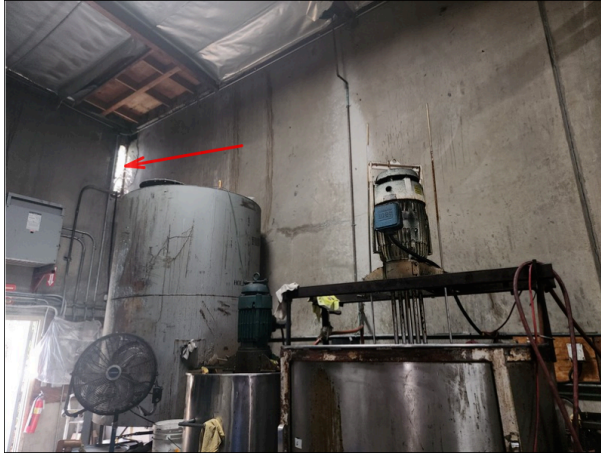
- Immediate consultation with a structural engineer to determine the cause of--and create a work plan for remediating--the observed separation of the western tilt-wall from the northern and southern tilt-walls.

Daylight visible at junction between two walls.

COST RECOMMENDATION	EUL	EFF AGE	RUL	YEAR	COST
Consult Structural Engineer	-	-	0	Immediate	\$1,500
Total					\$1,500

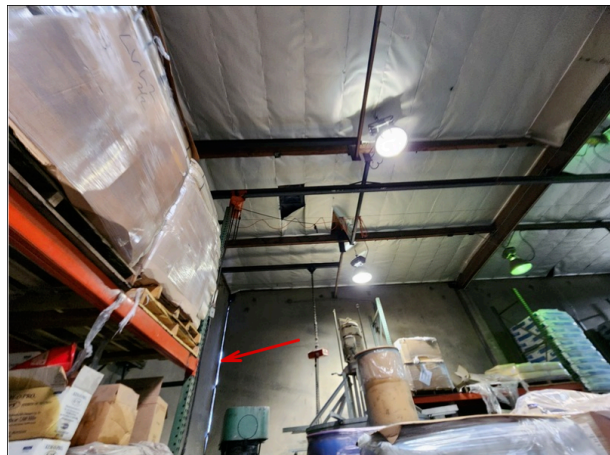
Daylight visible between walls.

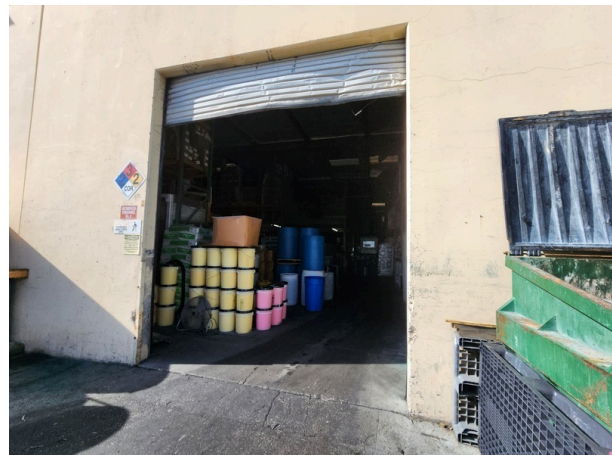
Other	Holes were observed in the parapet walls.
RECOMMENDATIONS	
Findings	<p>One of the Property's roll-up doors was damaged. CREtelligent recommends replacing this door to ensure a weather-tight seal at this location. Allowances have been provided in the Immediate Repair Cost Table.</p> <p>The holes in the parapet wall should be repaired and painted. This can be handled as part of routine maintenance.</p> <p>Depending on the quality of preparation of the surfaces, the quality of materials used, and weather conditions, painting, power washing, caulking, and sealing is typically required every eight to ten years. Brick pointing is typically required every 15 to 20 years. The building is are likely to require exterior maintenance during the evaluation period and allowances are included in the Modified Capital Reserve Table. Rotting or damaged wood, siding, and trim should be replaced as noted as part of the ongoing routine maintenance of the property and during pre-painting preparation.</p>

Damaged roll-up door.

COST RECOMMENDATION	EUL	EFF AGE	RUL	YEAR	COST
Exterior Maintenance	9	4	5	5	\$13,230
Replace Damaged Roll-up Door	-	-	0	Immediate	\$1,750
Repair Holes in Parapet Wall	0	0	0	Immediate	\$2,000
Total					\$16,980

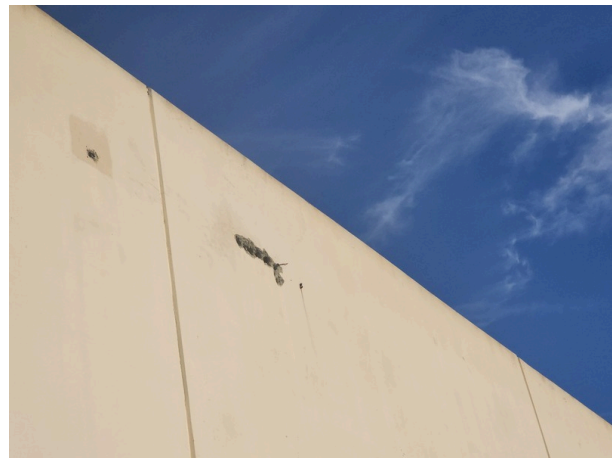
Holes in parapet wall.

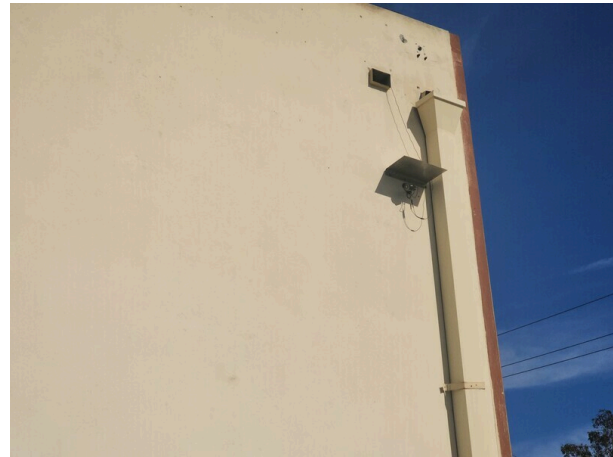
Parapet drain and scupper with missing downspout.

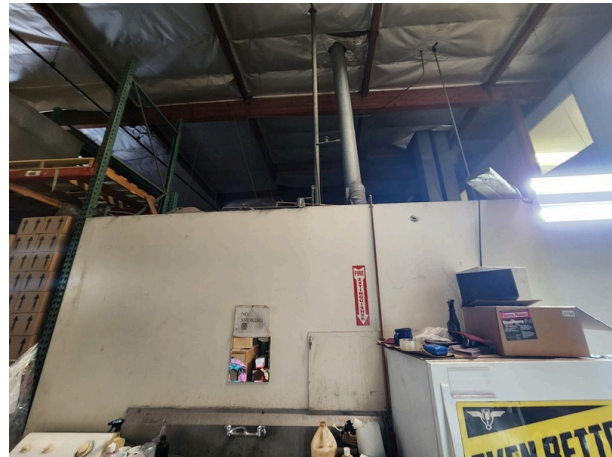
No longer in use ductwork.

COST RECOMMENDATION	EUL	EFF AGE	RUL	YEAR	COST
HVAC Professional Consultation	-	-	0	Immediate	\$1,800
Total					\$1,800

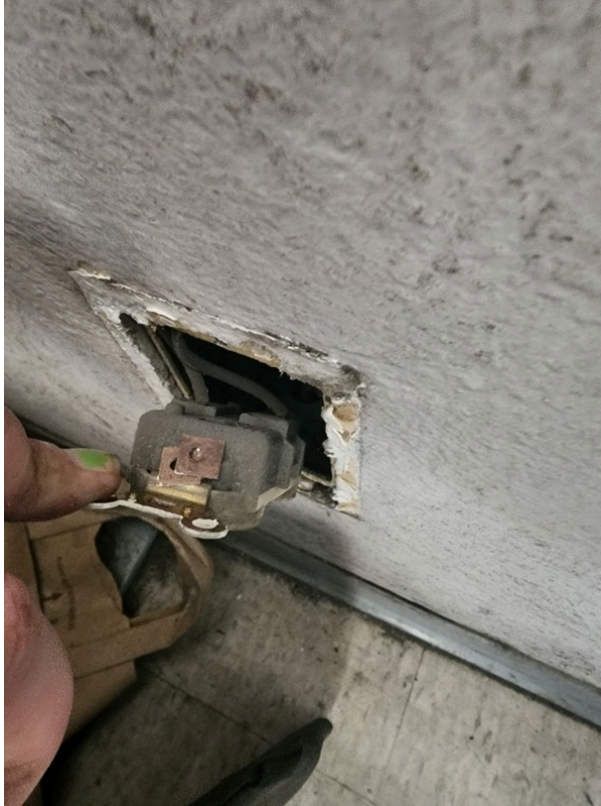
Outlet in office was not secured to wall.

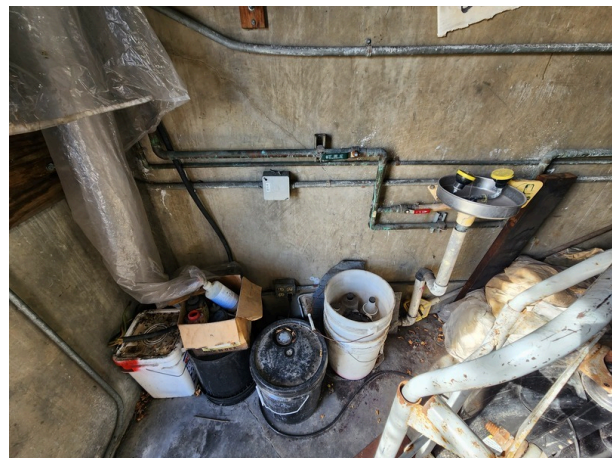
Copper water lines near eye-wash station are corroded.

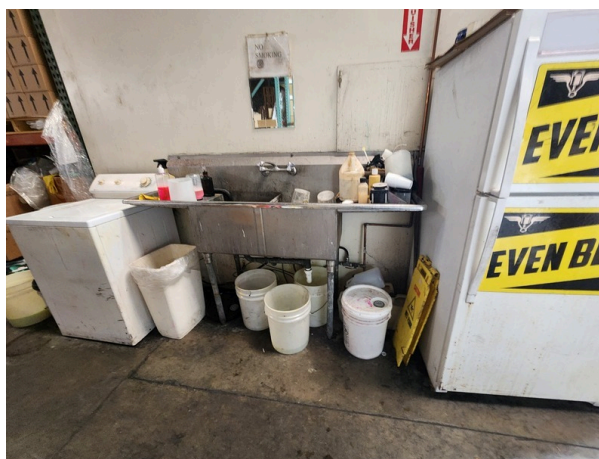
Missing fire extinguisher.

COST RECOMMENDATION	EUL	EFF AGE	RUL	YEAR	COST
Fire Extinguisher	0	0	0	Immediate	\$150
Total					\$150

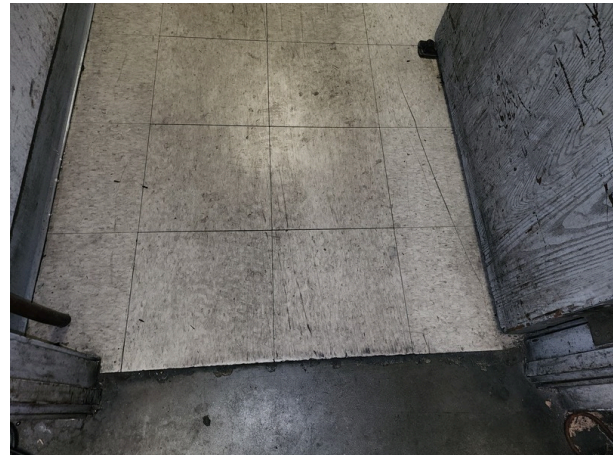
Damaged and stained vinyl flooring and trim.

COST RECOMMENDATION	EUL	EFF AGE	RUL	YEAR	COST
Replace Vinyl Tile Flooring	10	9	1	1	\$6,250
Office Wall and Ceiling Refurbish	10	9	1	1	\$3,000
Total					\$9,250

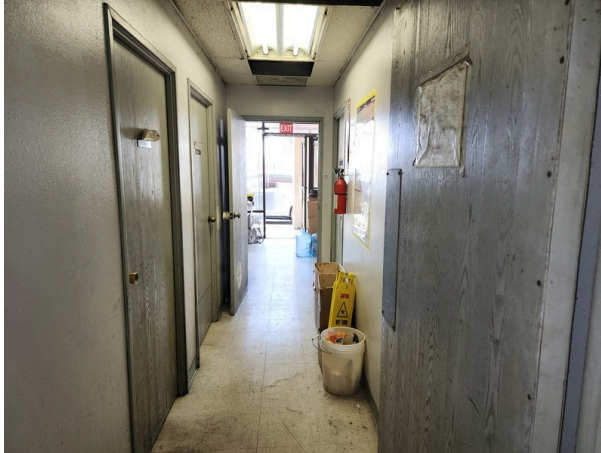
Missing ceiling tiles and damaged/stained flooring.

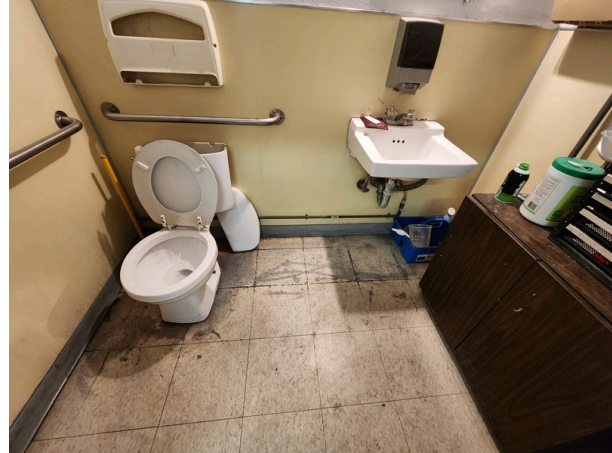
Bathroom with damage and stained fixtures and flooring.

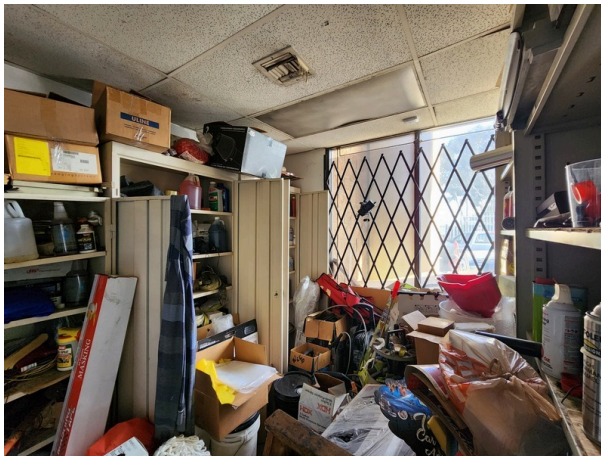
Office area: ceiling tiles are aging out and ceiling vent needs to be replaced.

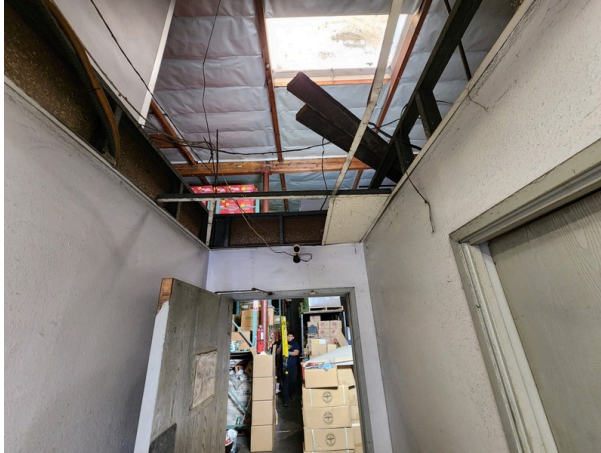
Corridor outside offices: missing ceiling tiles and damaged wooden door.

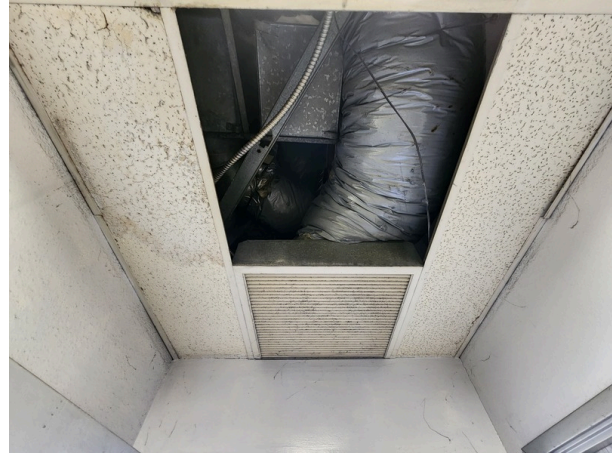
Office hallway: additional missing and aged-out ceiling tiles.

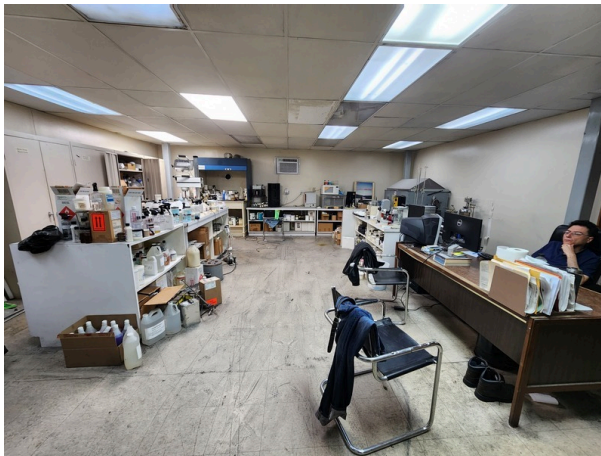
Laboratory finishes. Vinyl tile flooring is damaged and ceiling tiles are aging out.

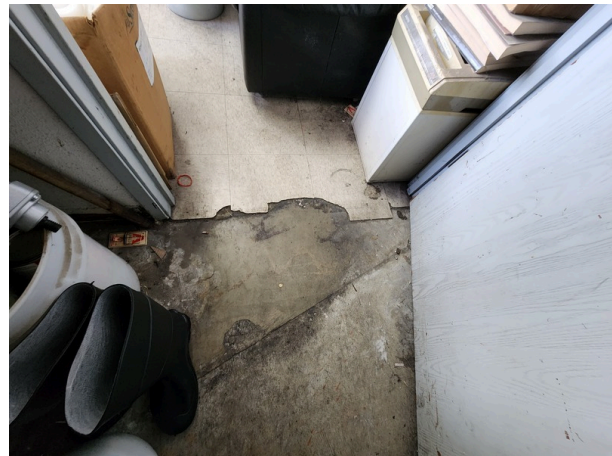
Laboratory flooring is damaged.

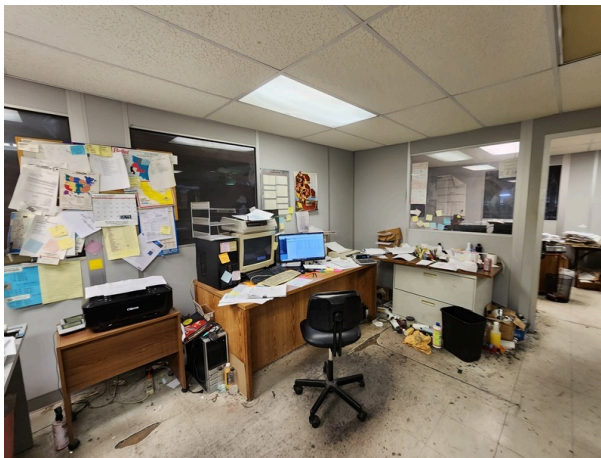
Damaged and stained office finishes on second floor.
