Property Condition Assessment

Subject Property:
Main Street, Anytown, CA 90000

RE Property Condition Assessment of
Sample Manufacturing
Main Street
Anytown, CA 90248
Warehouse, Storage

CREtelligent Project No.: 22K02-38231-130

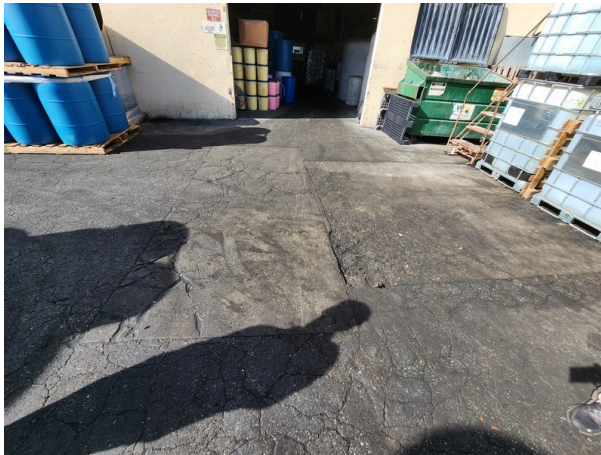
View of asphalt paving with concrete patching.

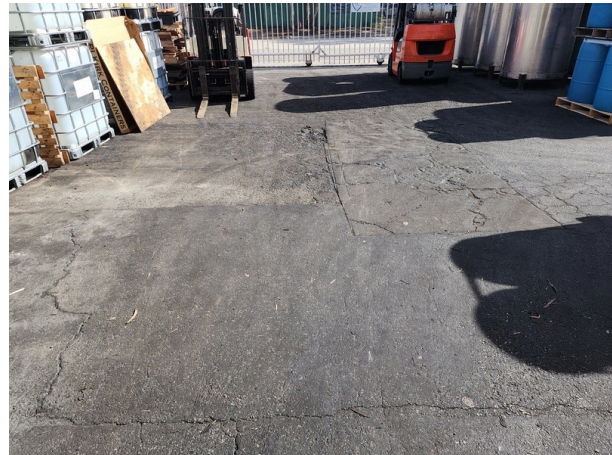
Additional asphalt with concrete patching.

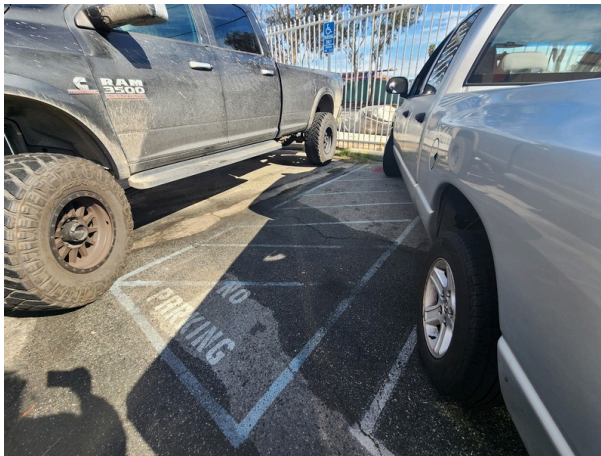
Faded parking stall striping.

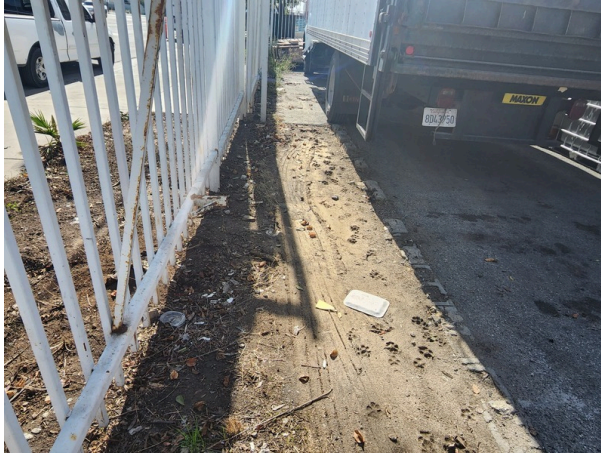
Bare soil inside fencing on eastern Property boundary.

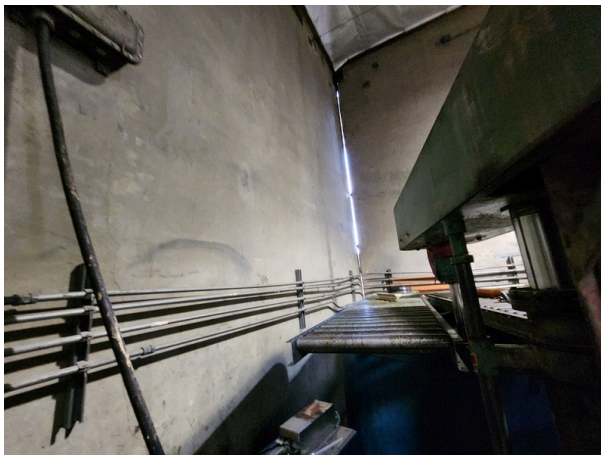
Daylight visible between walls.

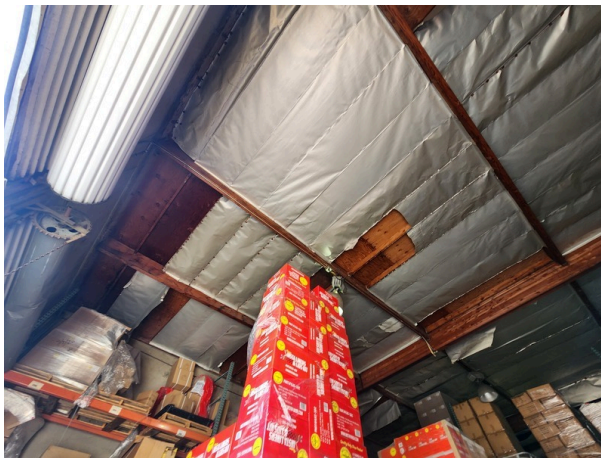
Tear in ceiling insulation shows roof decking.

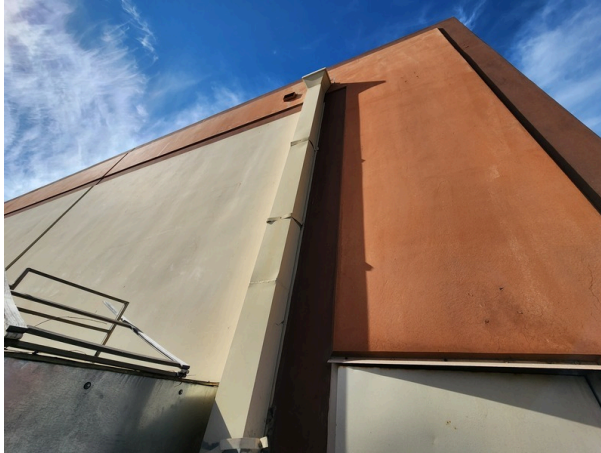
Downspouts and overflow scuppers.

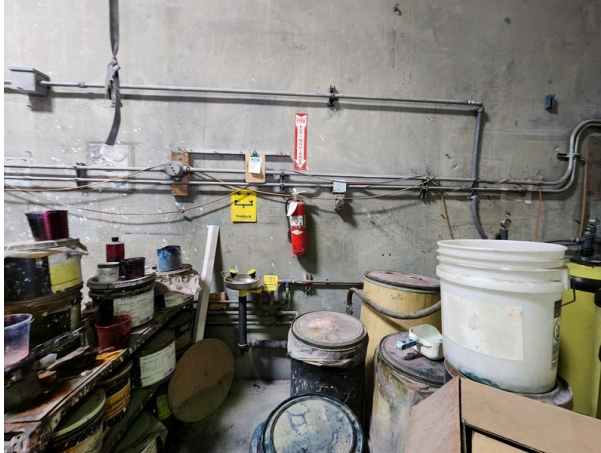
Water lines to eye wash station in mixing area.

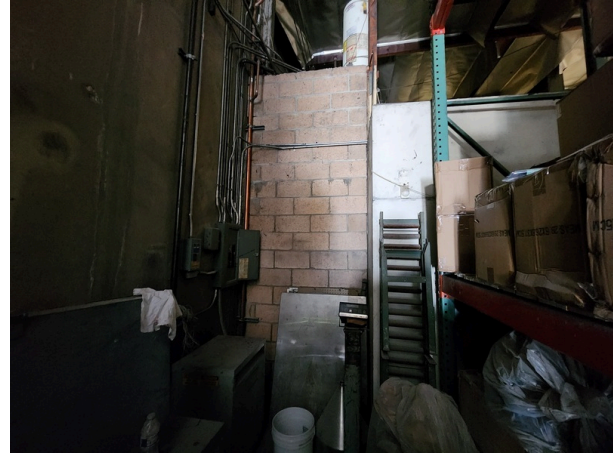
Copper water line near water heater.

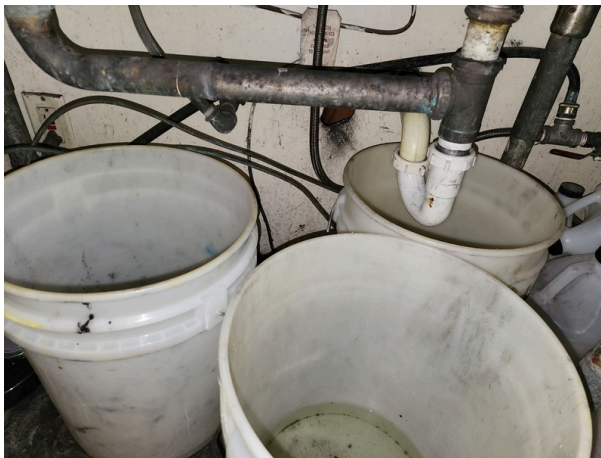
Under sink plumbing.

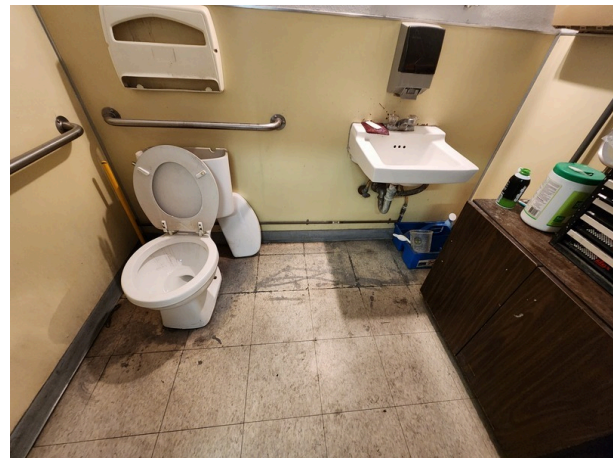
Supply and drain lines in restroom.

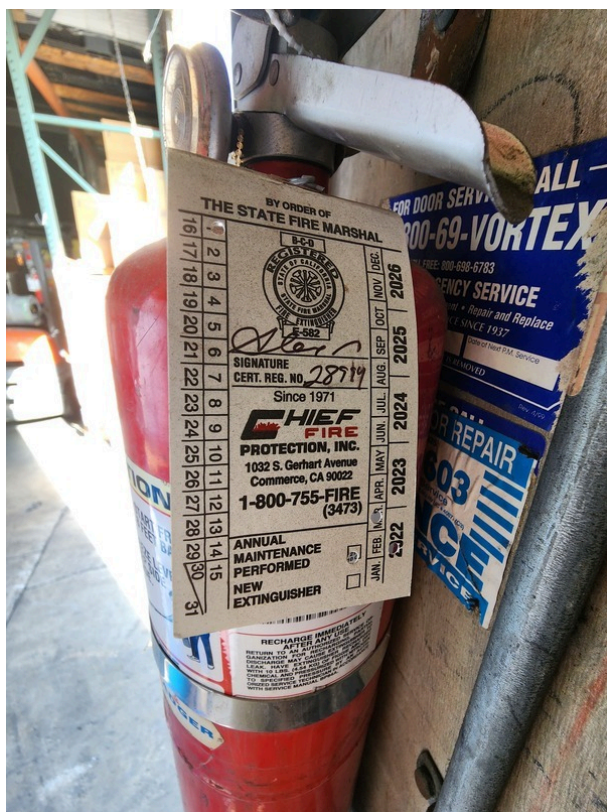
Fire extinguisher inspected March 2022.

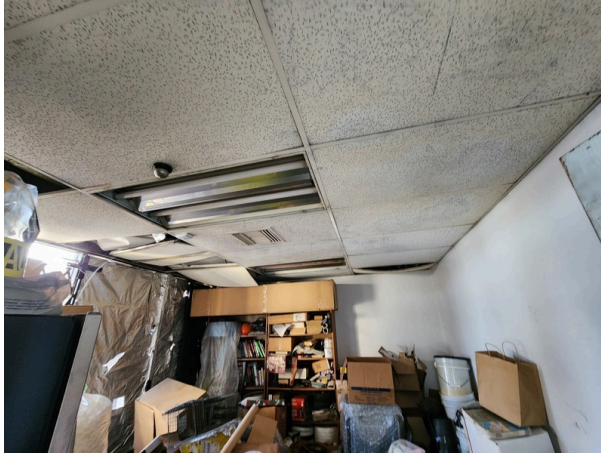
Security camera in office on ceiling.

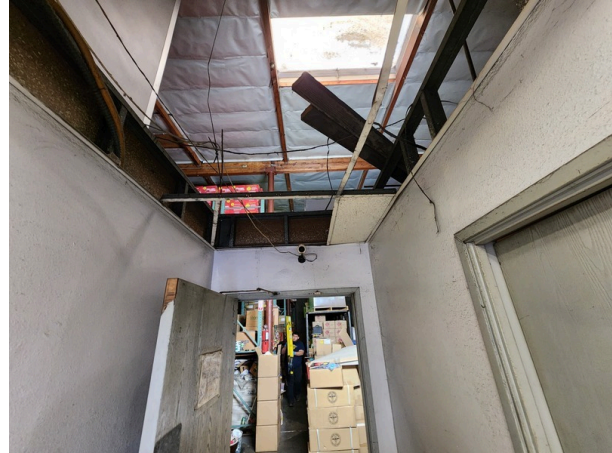
Security camera in office hall.

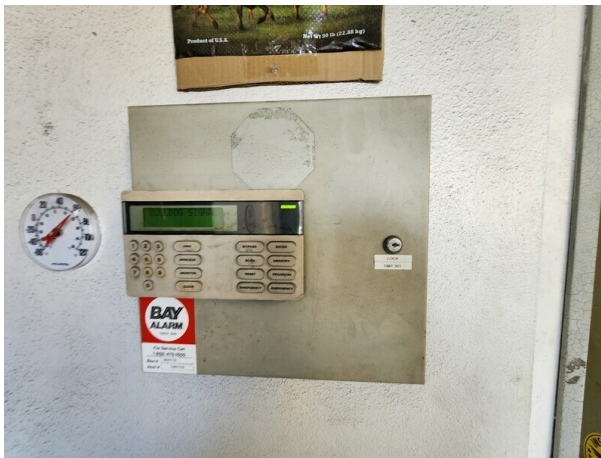
Security alarm panel.

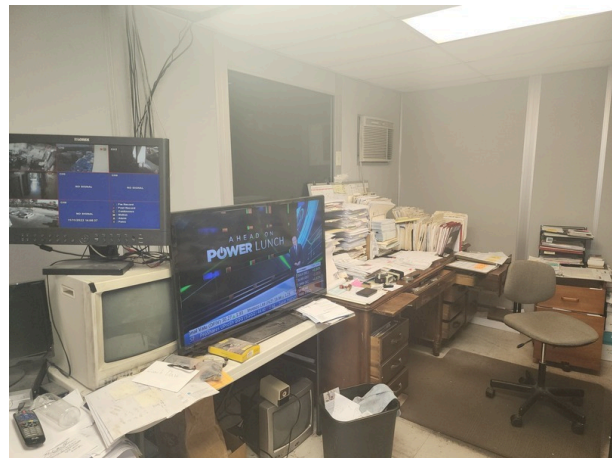
Security cameras monitored by onsite staff.

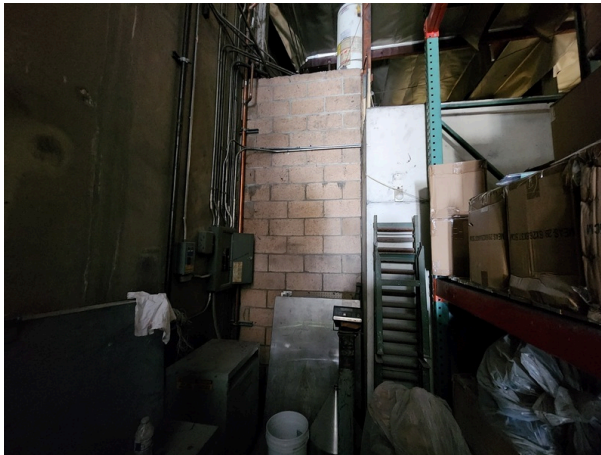
Unpainted concrete and CMU finishes.

COST RECOMMENDATION	EUL	EFF AGE	RUL	YEAR	COST
Replace Vinyl Tile Flooring	10	9	1	1	\$6,250
Office Wall and Ceiling Refurbish	10	9	1	1	\$3,000
Total					\$9,250

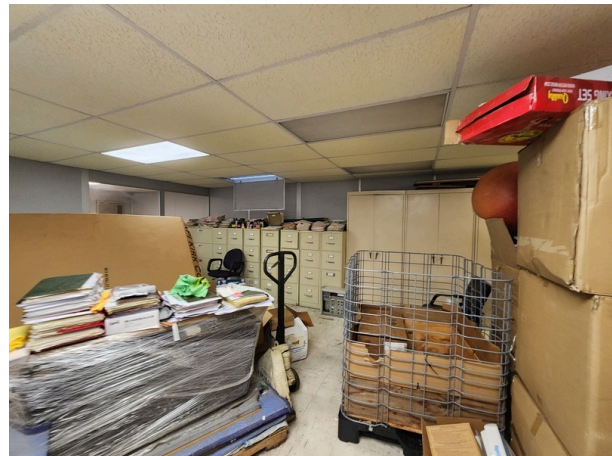
Office area finishes.

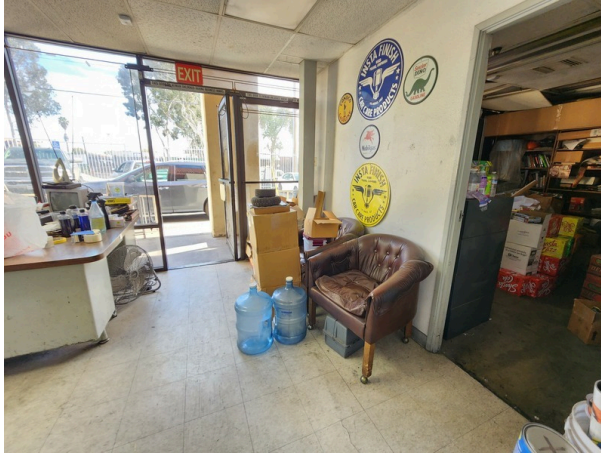
Foyer at main entrance finishes.

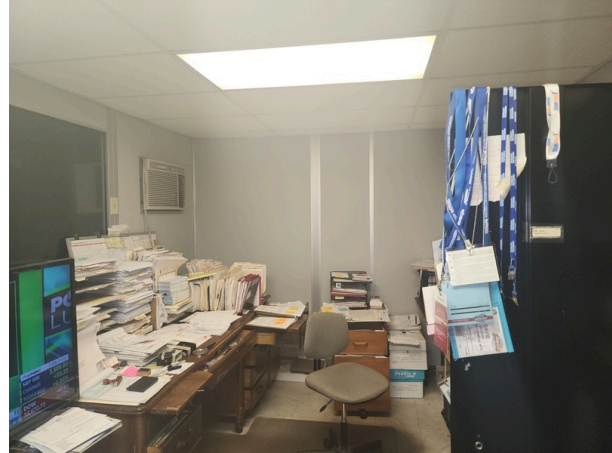
Second floor office finishes.
